## MANSION HILL INN

Exterior Ornamental Ironwork Restoration  
Madison, Wisconsin USA

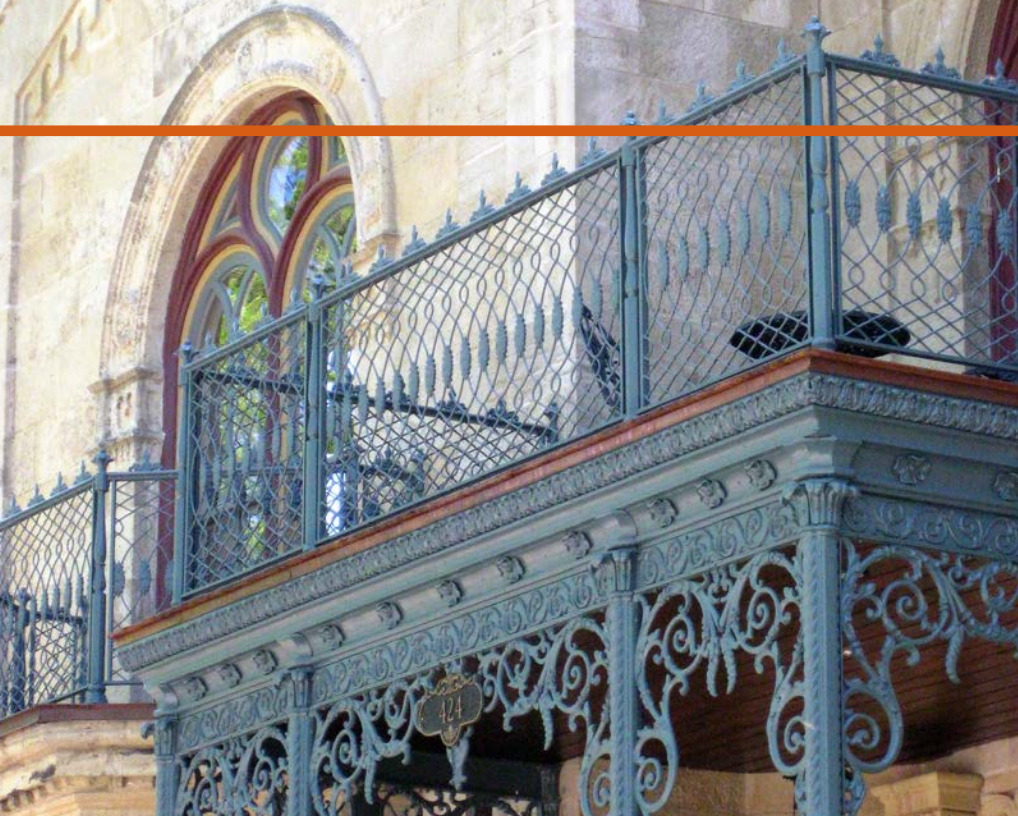
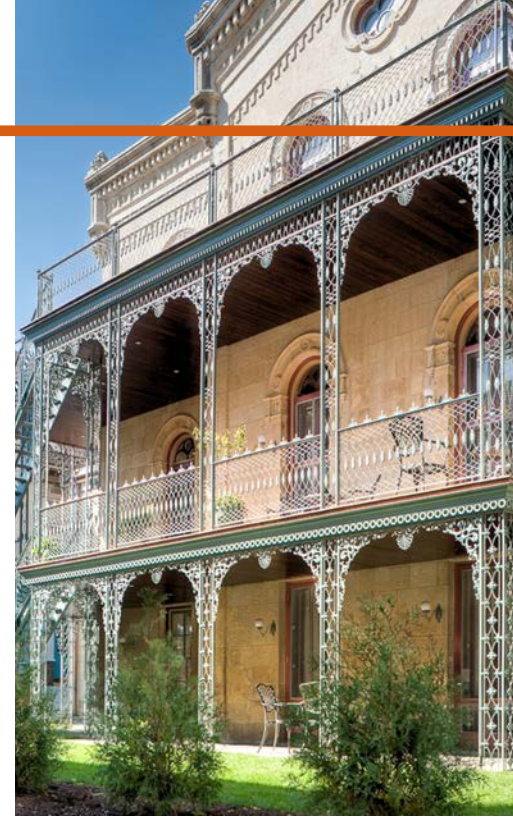
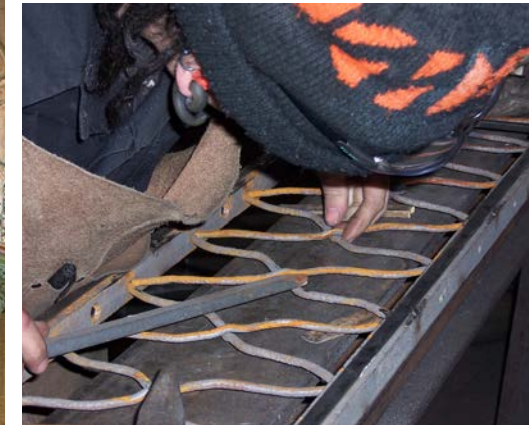
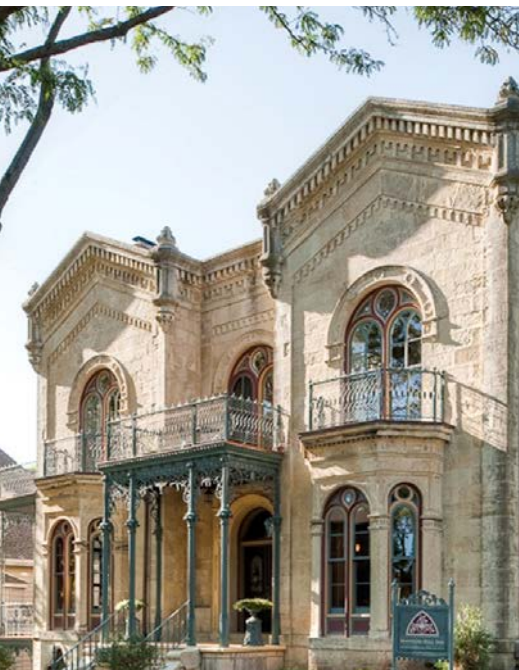
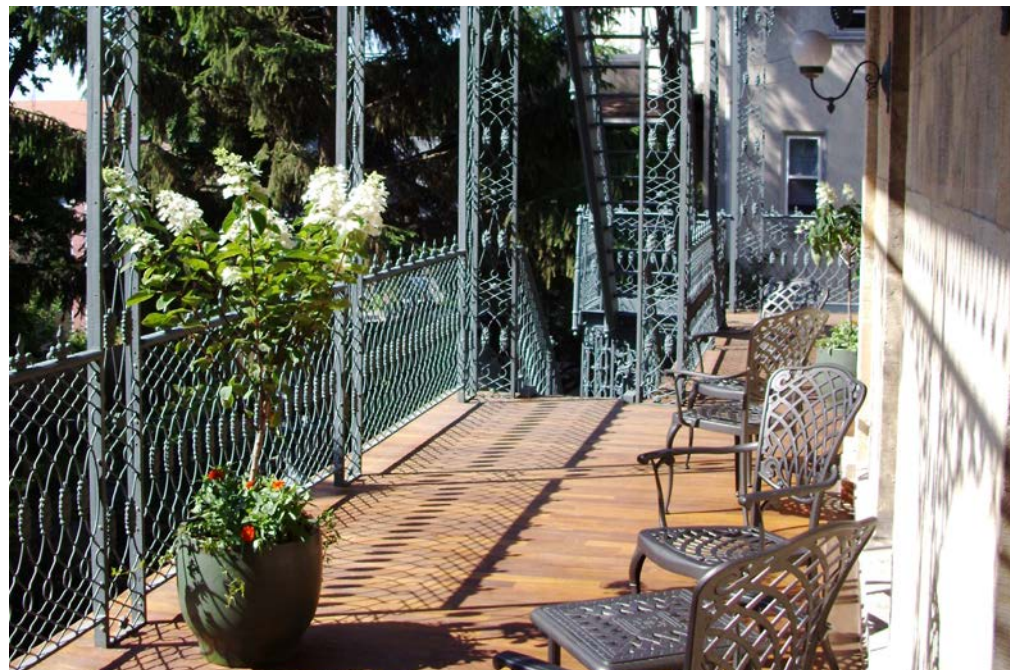
Banker Wire created a unique die to duplicate the original ironwork's slightly irregular decorative crimping pattern. Banker Wire created a unique die to duplicate the original ironwork's slightly irregular decorative crimping pattern. The crimped wires were then assembled individually by hand, in a process reminiscent of their 1857 creation. The restored pattern now sits again where it has for more than a century - atop the balcony over the inn's front entrance.
